4. TITLE AND SUBTITLE CONTAMINATION ASSESSMENT REPORT, PHASE I, SITE 1-10, SOUTH TANK FARM, TASK 2, SOUTH PLANTS, FINAL, VERSION 3.2

FINAL
PHASE I
CONTAMINATION ASSESSMENT REPORT
SITE 1-10
SOUTH TANK FARM
VERSION 3.2

April 1987 Contract No. DAAK11-D-0017 TASK NO. 2 - SOUTH PLANTS

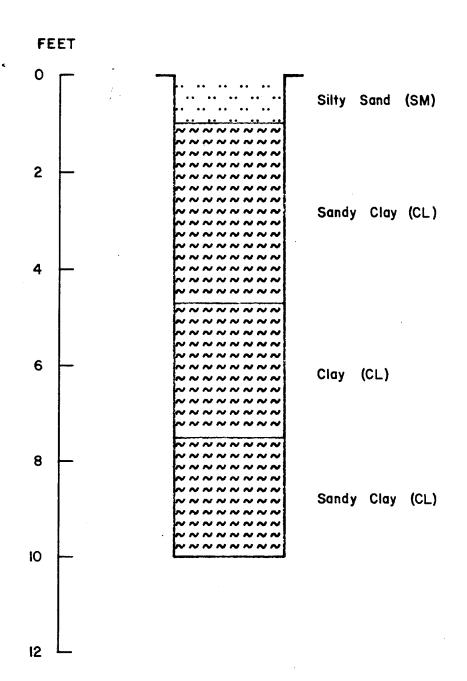
FIGURE 1-10-3

Field Boring Profile for Boring 2

The M8 alarm sounded at a depth of 10 ft during the drilling of Boring 2; however, the reading could not be verified by a second M8 or by the M18A2 test kit. No other indications of possible chemical agents were detected by these instruments. An M260 meter was used to detect oxygen concentrations and explosive levels. No significant deviations from background were noted. No unexploded ordnance, buried metal, or other buried objects were detected during drilling. No unusual coloring or staining of the core samples was noted.

The single occurrence of benzene was recorded at 7 micrograms per gram (ug/g) in the 9 to 10 ft interval of Boring 2. Boring 2 was the only boring drilled deeper than 5.5 ft, and the 9 to 10 ft interval was the only sample below the water table. Methylene chloride was reported in the 4 to 5 ft intervals of Borings 1, 2, and 3, all of which are located in the western portion of the site. The concentrations of methylene chloride ranged from 2 to 90 ug/g.

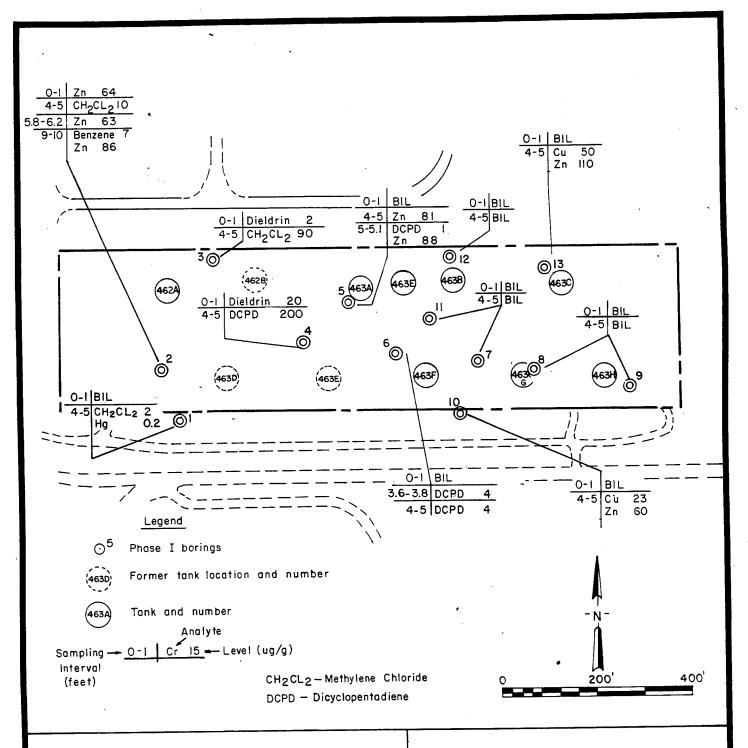
Program Manager's Office for Rocky Mountain Arsenal Cleanup Aberdeen Proving Ground, Maryland FIGURE 1-10-6
Analytes Detected Within or Above Indicator Levels

Phase I samples from Site 1-10 had detectable levels of benzene, dicyclopentadiene, methylene chloride, and dieldrin, and concentrations of copper, zinc, and mercury within or above indicator range.

Benzene was detected in the single soil sample from the water table at Site 1-10, and may be a reflection of the benzene found in the groundwater underlying the site. Although there was a benzene spill reported in the south tank farm area, there was no indication of this compound in the near-surface soils. Detected dicyclopentadiene concentrations were clustered in the

- o The vertical and horizontal extent of mercury in the vicinity of Boring 1;
- o The vertical and horizontal extent of dicyclopentadiene in the vicinity of Borings 4, 5, and 6;
- o Whether organochlorine pesticides, methylisobutyl ketone, and mercury extend into the northeast corner of Site 1-10 from Site 1-8;
- o Whether potential contaminants have leaked from the tanks onto adjacent areas; and
- o Whether the benzene concentrations detected in soils in or near the saturated zone at this site are the result of groundwater contamination.
